Philips redesigns burner for AM

The production and maintenance of quartz burners was causing some trouble. That's why Philips decided to redesign the burners, with the help of Sirris' expertise in additive manufacturing.

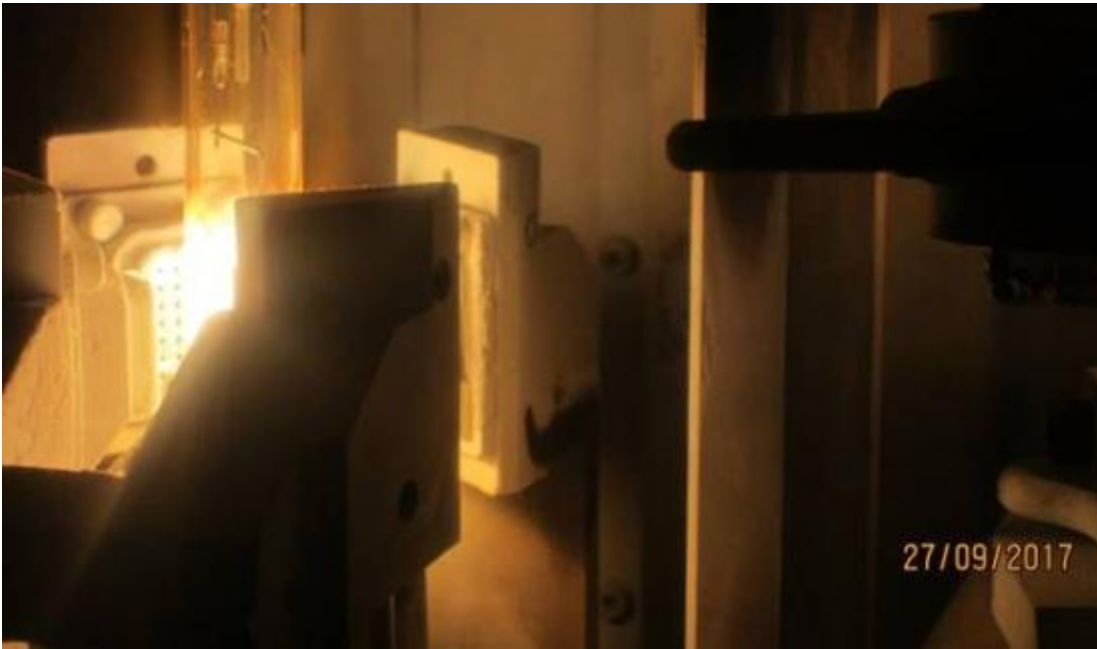
The new burners in action
