## Philips redesigns burner for AM

*The production and maintenance of quartz burners was causing some trouble. That's why Philips decided to redesign the burners, with the help of Sirris' expertise in additive manufacturing.*

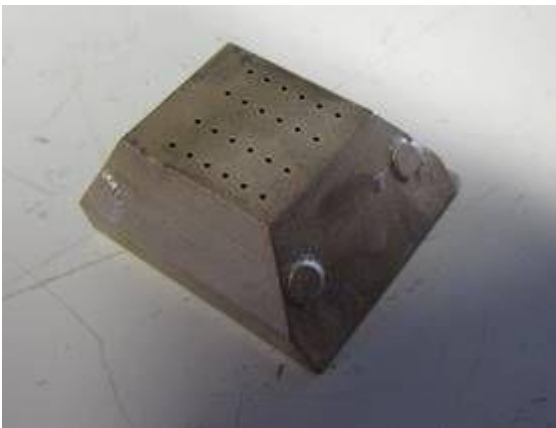
*Old burner*

The old burners were made from a copper alloy - to ensure proper cooling and because it allowed for brazing. However, the holes caused when the cooling channel was drilled, had to be closed.

The production of these burners met with quite some problems: it is not easy to make the drill holes watertight by means of brazing. When the first drill hole was soldered and the technician would

start on the second one, the first one would start to leak again because of the heat needed to solder the second one properly. When heating quartz, a lot of quartz fumes are released which are then deposited in cold places (for cooled burners). This meant the burners had to be cleaned (sandblasted) very often, which also caused the burners to leak.

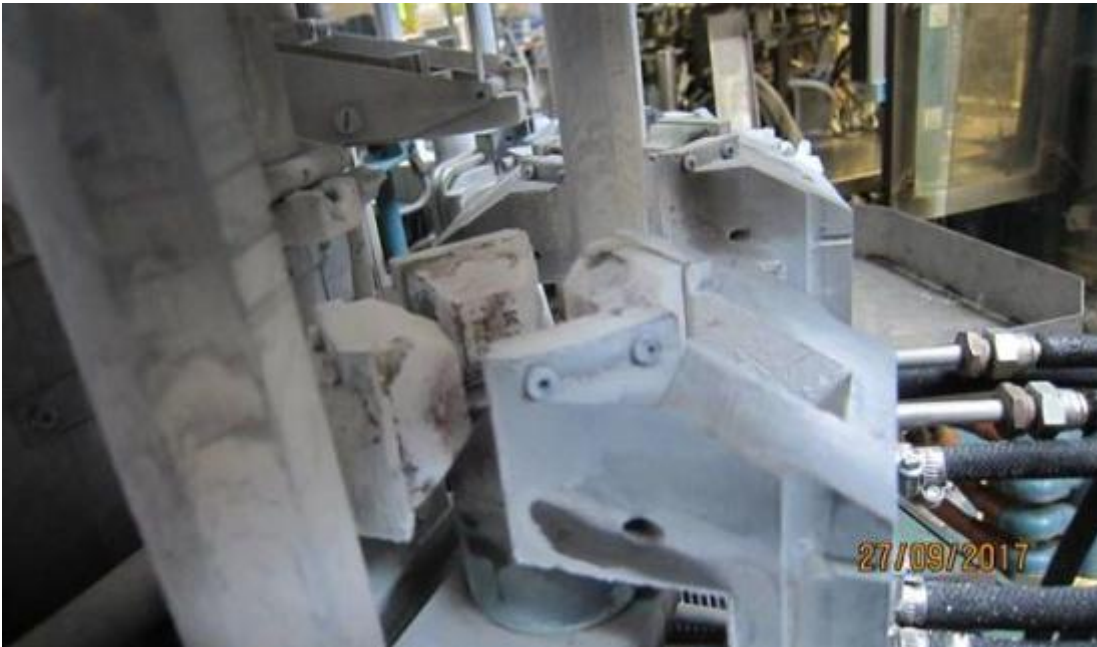
*Old burner on the machine with a great deal of quartz deposit*

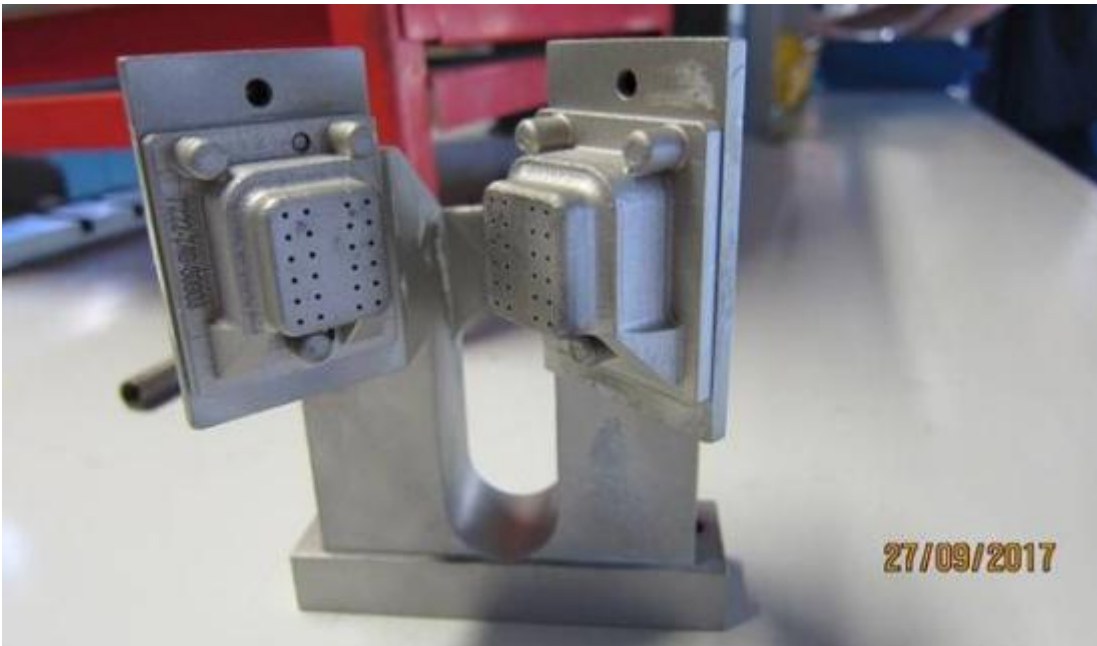
*The new burners assembled and cleaned*

In the redesign process the cooling channel was placed in the most optimal position and Philips used inconel as an alternative material, which has the property of absorbing fewer quartz vapours.

After two years there is still no need to replace the new burners. Cleaning requires no more than simply blow them clean with compressed air. This is definitely a successful redesign!

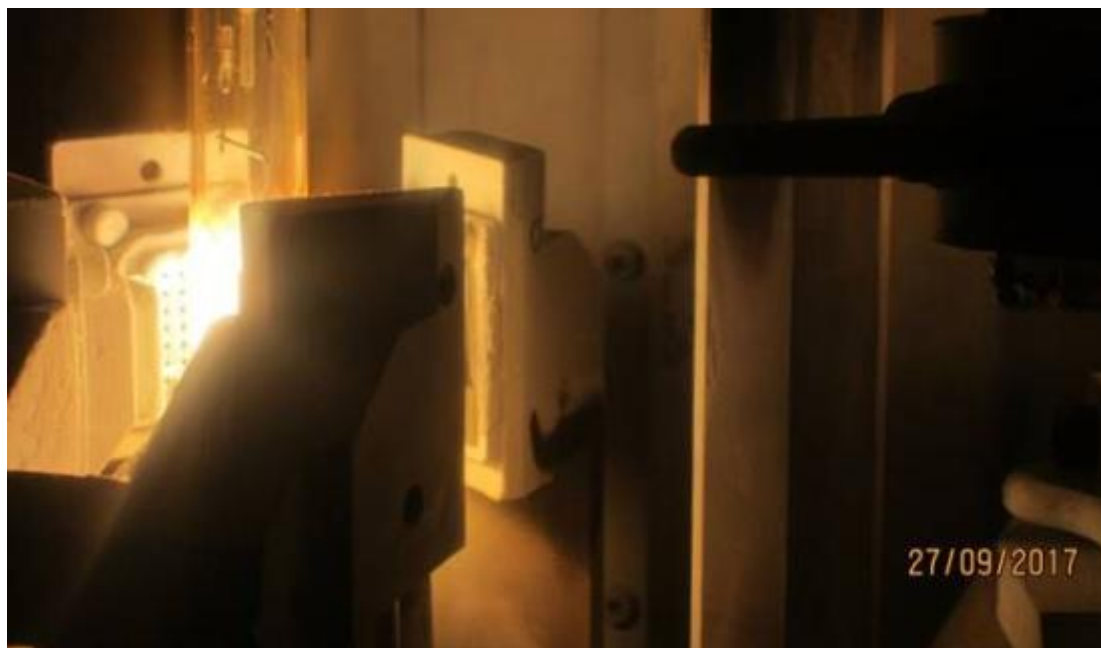
*The new burners in action*
